# Report Especially Prepared For:

Tina Buyer 123 Nice Home Way Shaler, PA 15090

Address of Inspection:	123 Nice Home Way, Shaler, PA 15090		
Client: Tina Buyer			
Date: 5/13/2013			
General Information		Invoice	
Seller's Agent:		Report Numbe	r: 20130513-1
Company: Phone:	( )	Inspection Type	pe: Visual
Email:	( )		
Emaii		Total Fee:	\$505.00
Buyer's Agent:	Johnny Agent	Paid By:	Check (#6543)
Company:	Home Sellers Realty		
Phone:	(412)-123-9876	NOTICE A Sin	
Email:	johnny@realestate.com		ance charge of the maximum amount allowed in this state ed and assessed monthly from the escrow termination
Weather Conditions:	Sunny 45 ° Fahrenheit	date until paid.	
Property Status:	Occupied		
	. □ Vacant

# **Property Analysis Report**

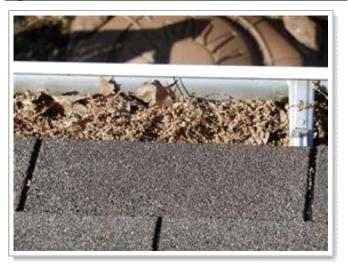
#### Figure Number 2

The gutters are clogged with leaves and debris. Clogged gutters can deposit substantial amounts of water against the foundations, leading to basement moisture entry. Keep gutters clean and free-flowing.

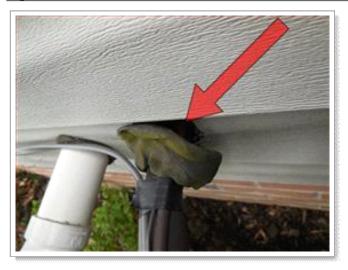
Openings in the exterior envelope of the structure at utility entrances should be sealed to help prevent pest and moisture entry. Filling openings with an approved material is recommended.

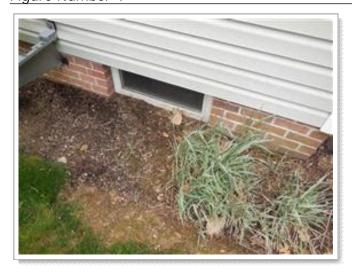
# Figure Number 4

Window openings that are very close to grade or below are subject to moisture entry, damage and will be difficult to keep clean. Installation of a window well or pocket with proper drainage provisions will help to protect this opening in the exterior wall.

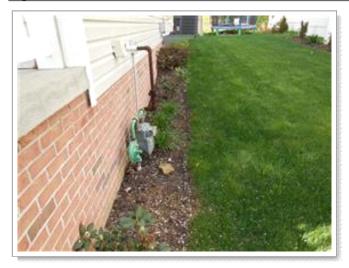
Create and maintain a slope of soil away from the foundation to divert water to the yard. Areas of negatively sloped soil will direct water to the foundation area and contribute to dampness or water entry into the foundation. Constructing a slope of soil that ideally would be equivalent to one inch of rise per foot of run away from the foundation is suggested. This slope should extend approximately six feet away from the building exterior to bridge the disturbed soil in the foundation trench. These dimensions are suggestions only and may be limited by proximity to other objects and siding materials.

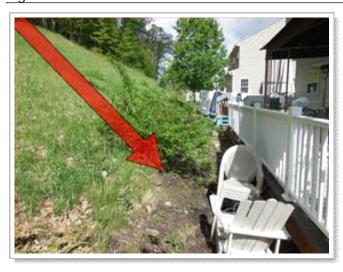
#### Figure Number 7

The steep hill side at the rear of the house will direct water to a close proximity of the house. Be sure to monitor this area for poor drainage. Inquire if a yard drainage system is present as it appears that one may have been installed.

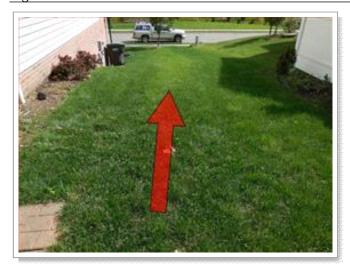
#### Figure Number 8

The steep hill side at the rear of the house will direct water to a close proximity of the house. Be sure to monitor this area for poor drainage. Inquire if a yard drainage system is present as it appears that one may have been installed.

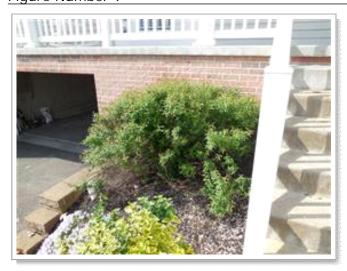
#### Figure Number 9

Landscape vegetation is planted in close proximity or is in contact with the building exterior. Branches that touch or ivy that grows on the siding material can be detrimental to the veneer in several ways including physical damage, moisture retention and providing an access route or harborage for pests. It is suggested that all vegetation be trimmed back at least two feet from the exterior walls and in the case of ivy it should be removed. This maintenance will help to prevent physical damage, allow air and sunlight to dry building components and eliminate pest access routes and harborage.

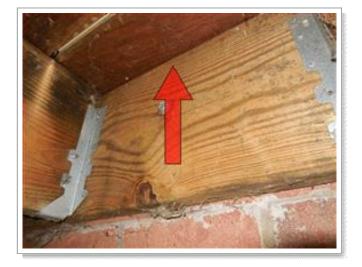
There appears to be no flashing between the deck ledger and the house. This can cause hidden water damage to the band joist framing, resulting in failure of the deck connection to the house. While there is currently no evidence of leakage and damage, this item is listed as a concern because the damage, when present, can be hidden and serious. Install deck ledger flashing is recommended.

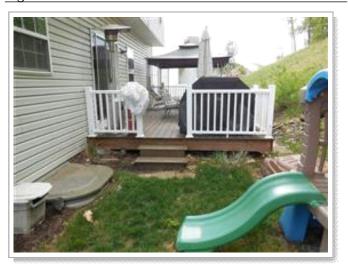
#### Figure Number 11

The deck is constructed on or very close to grade. Wood structures constructed in close proximity to the ground are subject to moisture and pest problems. Due to the close proximity to the ground it is not possible to fully evaluate conditions below the deck.

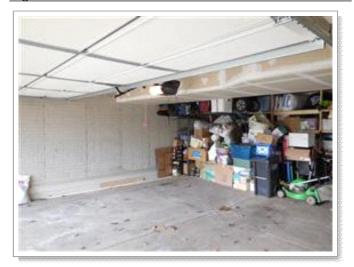
The occupant's belongings and /or storage units obstruct the view of portions of the garage walls. Prior to closing, a careful evaluation of the garage walls and floor for signs of unusual moisture staining or cracking that may have been concealed during this inspection should be performed after the occupant's belongings have been removed.

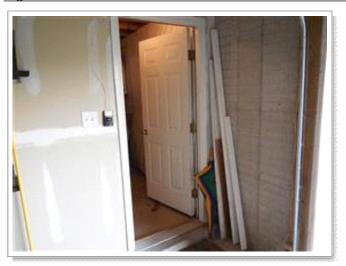
#### Figure Number 13

Self closing hinge(s) at the door to the interior are not functional. Installation of the hinge(s) is recommended.

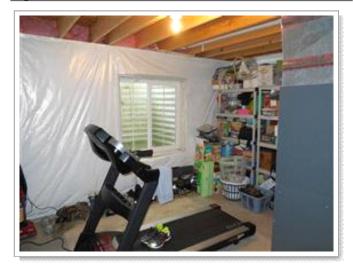
Portions of the foundation walls that are concealed behind insulation cannot be visually inspected for cracks and moisture. Although no unusual conditions were readily observed or detected, we cannot guarantee the condition of the foundation wall in this area. Inquiry with the seller for documentation concerning any previous cracking or moisture entry is recommended. Information to ask for also includes knowledge of any waterproofing systems, vapor barriers, water removal systems or previous action to correct moisture or water entry into the finished area of the basement. Monitoring of the finished basement for moisture entry is recommended so that timely corrective action will minimize any moisture related damage.

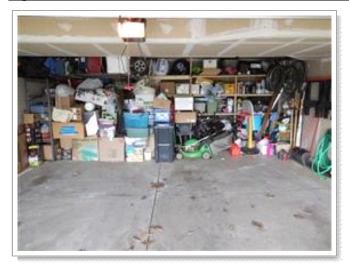
#### Figure Number 16

Occupant's belongings obstruct the view of portions of the foundation walls. Moving of personal property is not performed. Inquiry with the seller for documentation concerning any moisture entry, unusual cracking or corrective actions is recommended. Careful examination of the walls after the occupant's belongings have been removed is recommended.

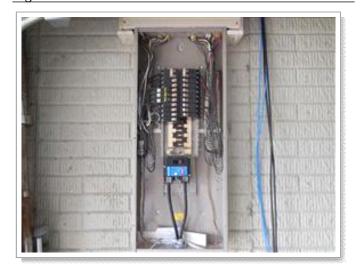
#### Figure Number 18

Branch Feeder Arc Fault Interrupters were present at this panel. These are the first generation of this breaker technology, and while better than common breakers they are not as responsive as they were intended to be. They are now considered obsolete. Up grading to newer Combination Type AFCI breakers should be considered for safety enhancement.

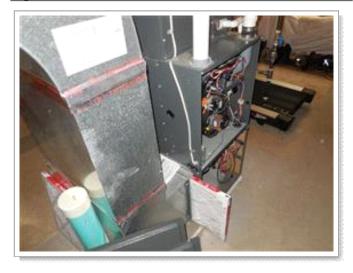
The closed combustion chamber design of the heating system prevents evaluation of the heat exchanger system. Further evaluation of the heat exchanger requires disassembly of the furnace and is beyond the scope of this inspection. This type of inspection can be performed by a qualified heating contractor and should be done as part of a regular maintenance program.

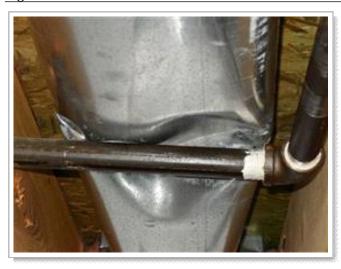
Damaged duct work was noted at the supply to the dining room. Monitor for insufficient air flow as crushed ducting can restrict the intended supply to this room.

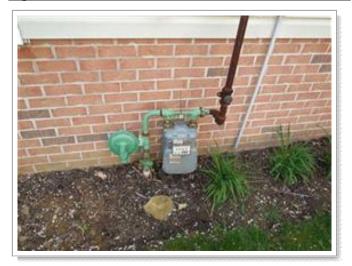
#### Figure Number 24

Whenever CSST (Corregated Stainless Steel Tubing) is used for gas distribution, the gas system should have a direct bond to the electrical grounding system. Bonding is done to maintain an equivlant charge on the metal systems of a building and reduce the potential for arching which can damage the CSST material. This is an inexpensive and easily installed safety feature that is specified by the manufacturer.

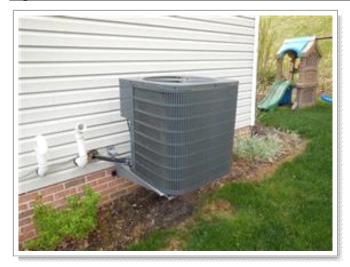
The air conditioner was not operated due to the ambient temperature being below 65 degrees. Operation during cold temperatures can cause damage to the compressor unit and does not yield accurate testing results. Consult with your Realtor about creating an addendum for further evaluation by a qualified contractor or other provision such as a home warranty to protect you in case of faulty operation.

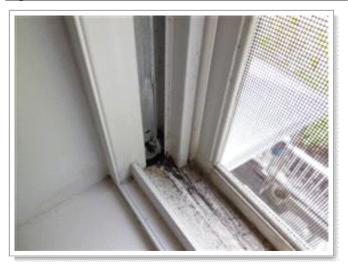
The rear center bedroom window has damaged hardware. Repair or replacement is recommended.

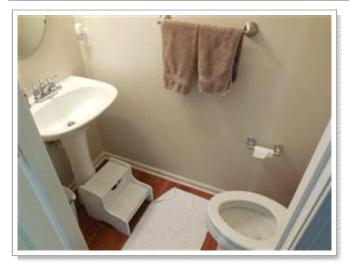
The toilet is loose at the floor. Evaluation for the need of a new wax seal is recommended before tightening the toilet base to the floor. This will help to prevent leakage that may cause damage to the floor and ceiling components below.

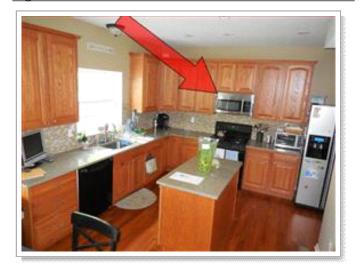
The "exhaust fan" is a recycling unit. If possible range hoods should discharge to the exterior to exhaust cooking odors and combustion by-products.
