# Report Especially Prepared For:

Tina Buyer 123 Nice Home Way Shaler, PA 15090

Address of Inspection:	123 Nice Home Way, Shaler, PA 15090		
Client: Tina Buyer			
Date: 5/13/2013			
General Information		Invoice	
Seller's Agent:		Report Numbe	r: 20130513-1
Company: Phone:	( )	Inspection Type	pe: Visual
Email:	( )		
Emaii		Total Fee:	\$505.00
Buyer's Agent:	Johnny Agent	Paid By:	Check (#6543)
Company:	Home Sellers Realty		
Phone:	(412)-123-9876	NOTICE A Sin	
Email:	johnny@realestate.com		ance charge of the maximum amount allowed in this state ed and assessed monthly from the escrow termination
Weather Conditions:	Sunny 45 ° Fahrenheit	date until paid.	
Property Status:	Occupied		
	. □ Vacant

# **Property Analysis Report**

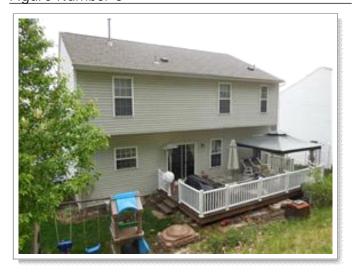
#### Figure Number 5

Window openings that are very close to grade or below are subject to moisture entry, damage and will be difficult to keep clean. Installation of a window well or pocket with proper drainage provisions will help to protect this opening in the exterior wall.
